GIANT FOREST  
**SEQUOIA**

**A Historical and Architectural Study of  
Three Rustic Structures at Giant Forest in Sequoia National Park  
The Market, District Ranger's Residence, and Comfort Station**

**HISTORIC STRUCTURES REPORT  
SEQUOIA NATIONAL PARK**

Approved  
December 7, 1988

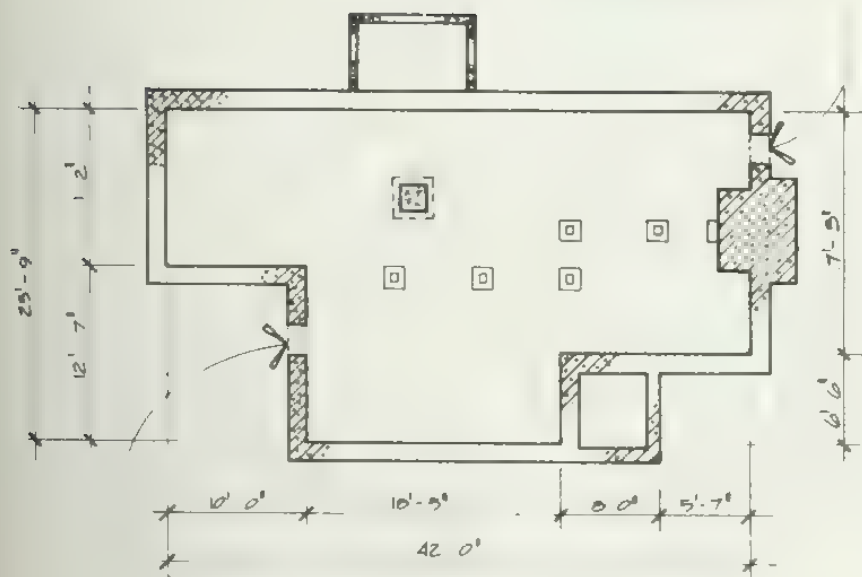
**FOUNDATION**

CRAWL SPACE VENT IS PARTIALLY BLOCKED AND VENT SCREEN IS DETERIORATED

CRAWL SPACE ACCESS DOOR IS DETERIORATED

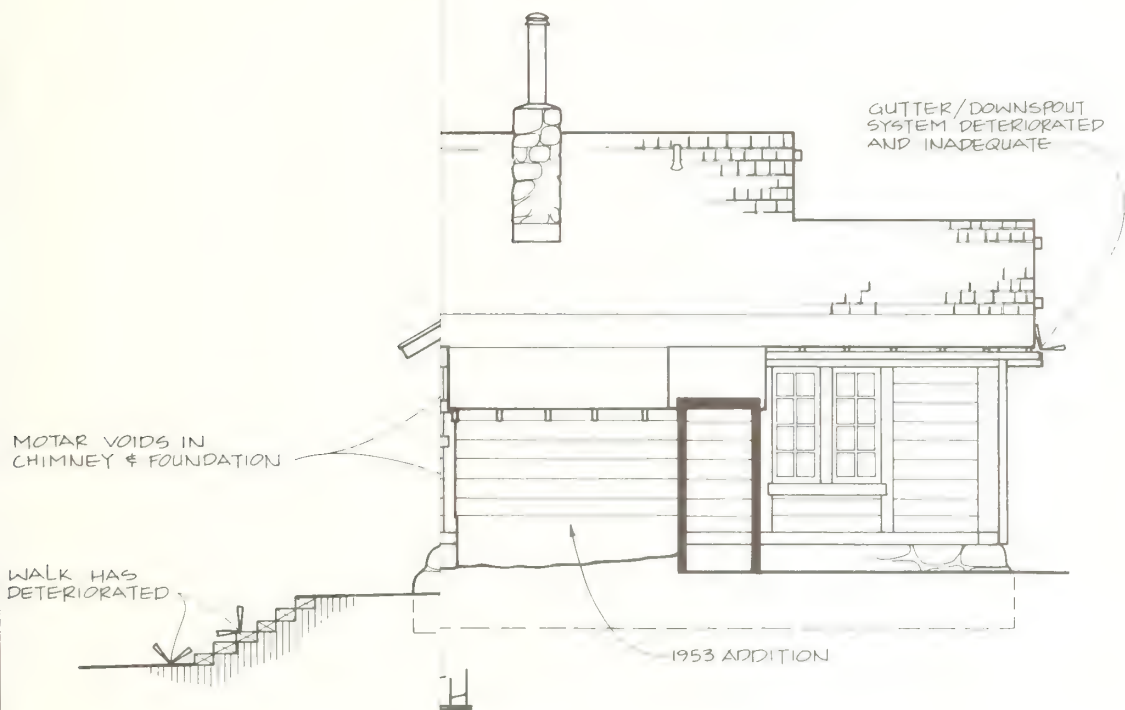
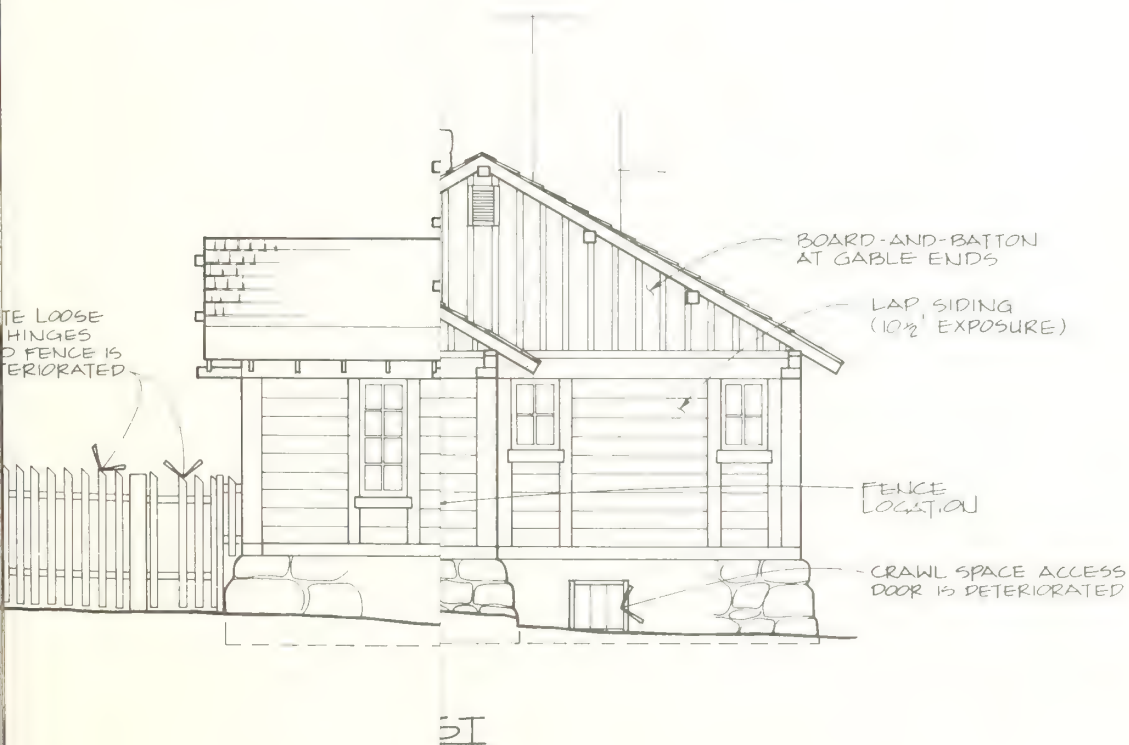
RANGER RESIDENCE  
ELEVATIONS  
DEFICIENCIES

WOOD SHINGLE ROOF AND SHEET METAL  
SNOW FLASHING IS AGED AND EXPECTED  
TO FAIL BY 1999

CRAWL SPACE VENT IS  
PARTIALLY BLOCKED AND  
VENT SCREEN IS DETERIORATED

GUTTER/DOWNSPOUT  
SYSTEM DETERIORATED  
AND INADEQUATE

MORTAR VOIDS IN  
CHIMNEY & FOUNDATION

WALK HAS  
DETERIORATED

INADEQUATE SPARK  
ARRESTOR AT CHIMNEY

EXTERIOR PAINT FINISH  
IS DETERIORATED

\*EXISTING CRAWL SPACE  
PLUMBING IS DETERIORATED  
AND SUBJECT TO FREEZING

GATE LOOSE  
AT HINGES  
AND FENCE IS  
DETERIORATED

CRAWL SPACE ACCESS  
DOOR IS DETERIORATED

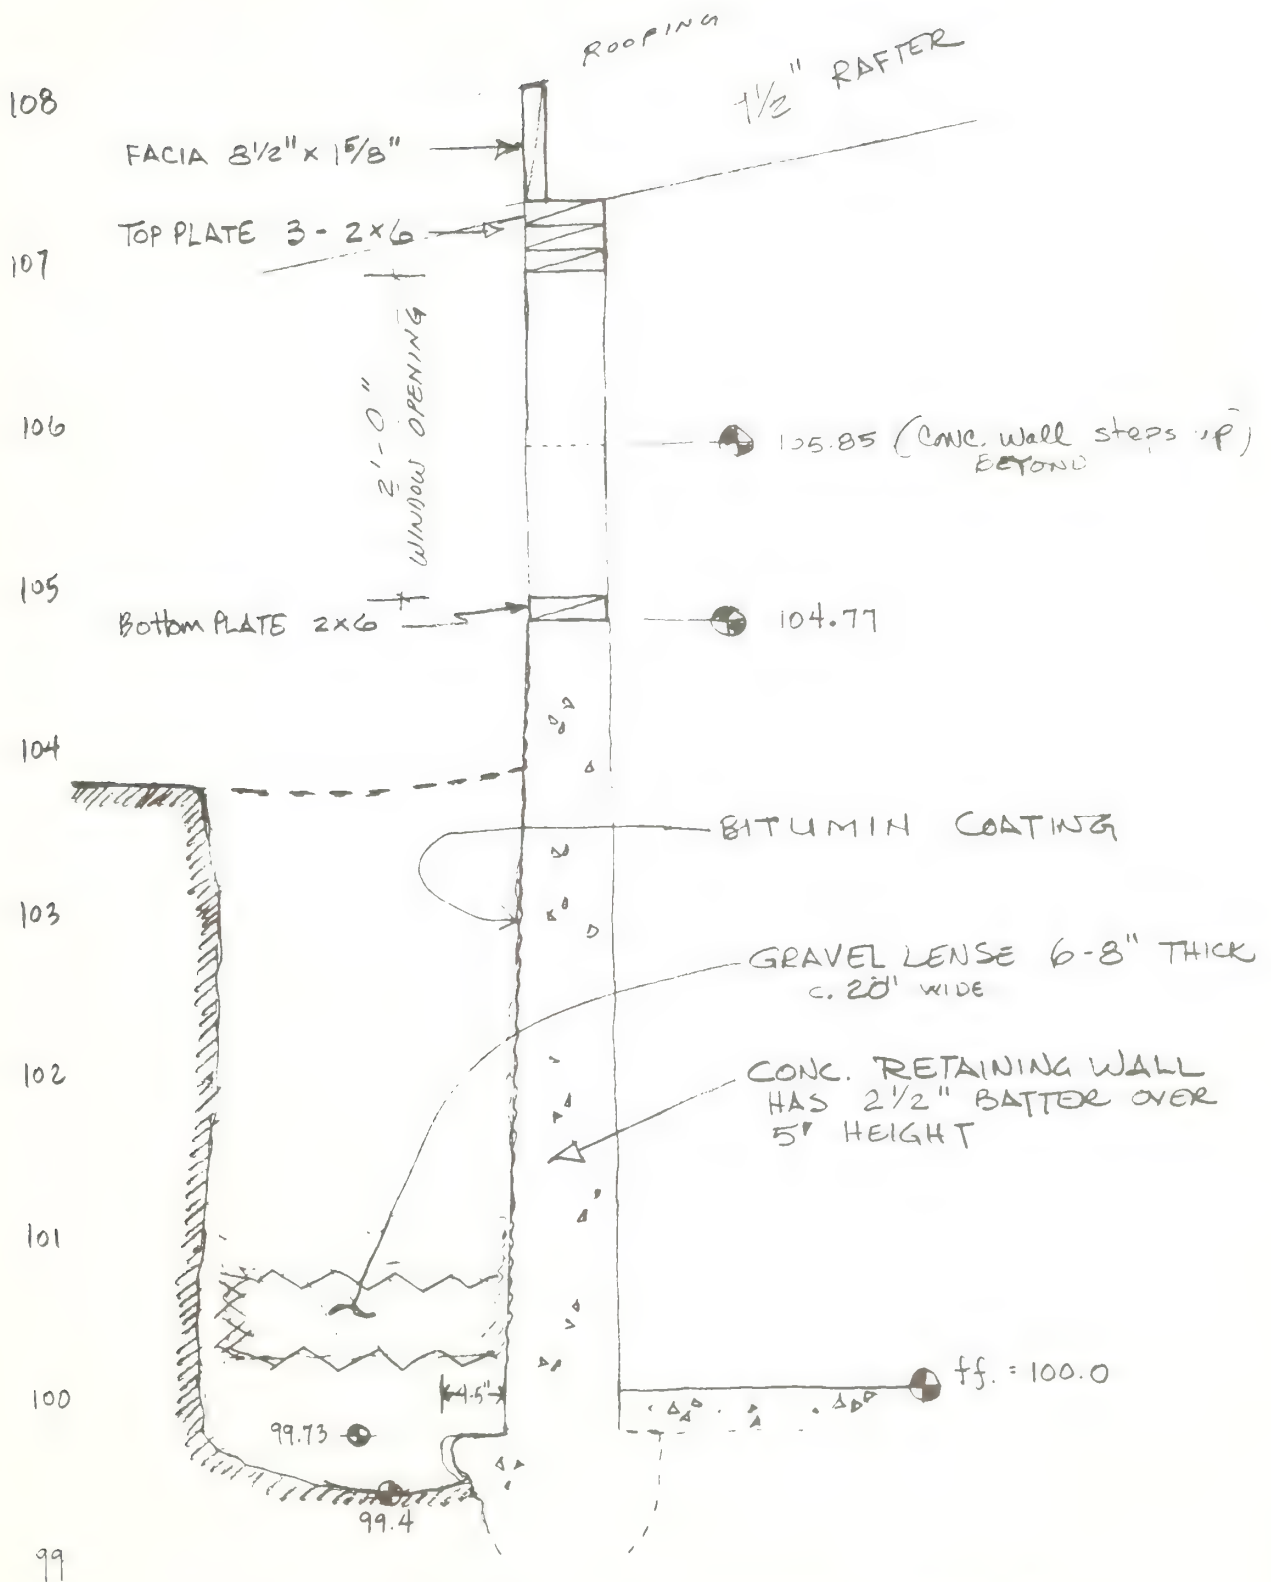
Figure A-5. Section at Test Pit 'D'

TEST PIT 'D' (NOTE TEST PIT 'E' SIMILAR)

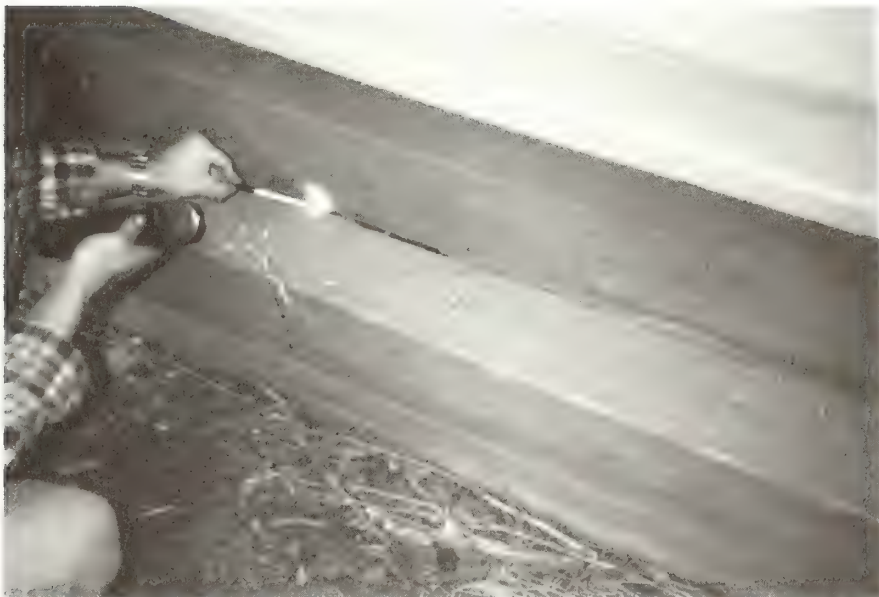
Figure A-7. Market, South Wall at Sill (10/86). To the west of the southeast corner along the south wall of room 100, this view shows additional gaps between siding and sill beam--an access for insects and moisture.

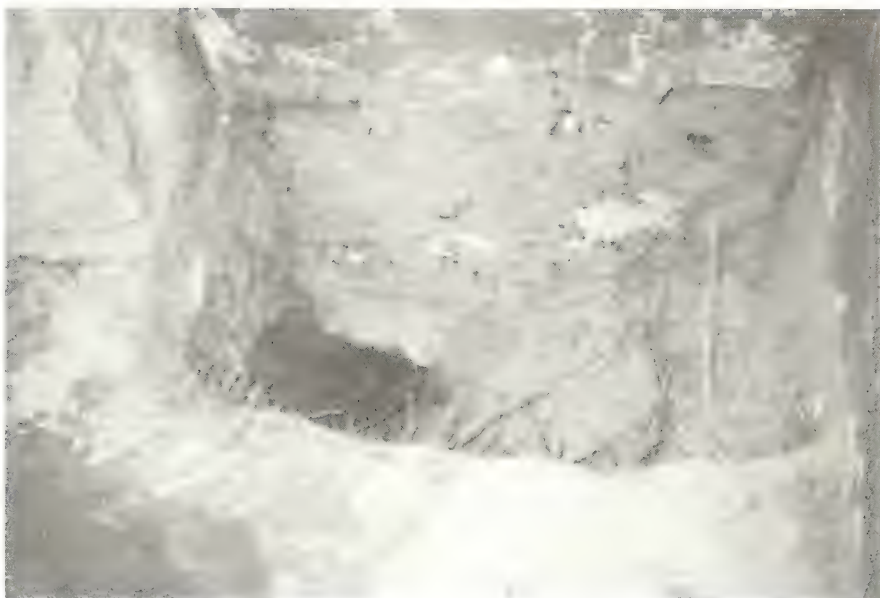
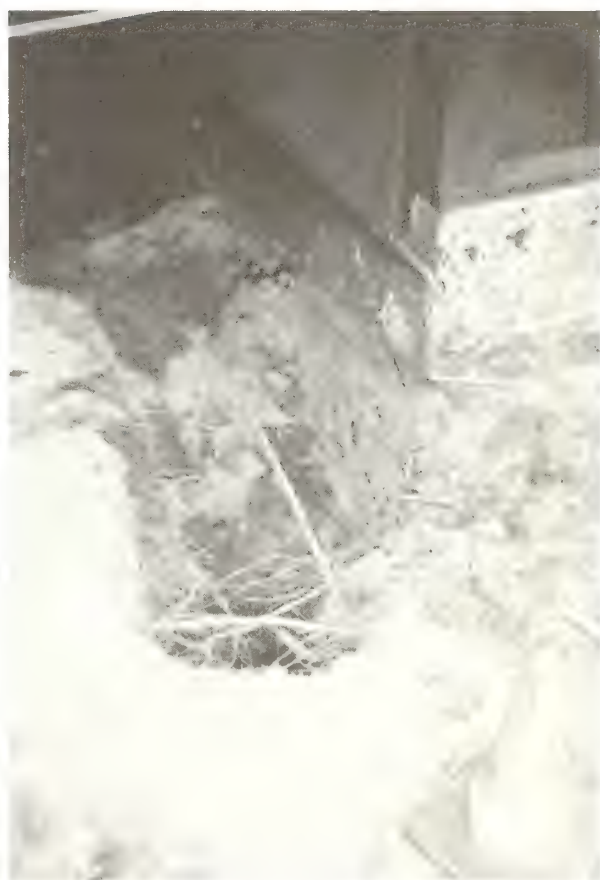
Figure A-10. Market, test pits B and C (10/86). The upper view shows the extent of excavation at the juncture between the east wall of the market, the 1930 chimney, at left, and the 1938 addition retaining wall, at right. At a depth of 5 feet was found the concrete footing, detail at bottom left. The photograph at bottom right shows test pit C at the southeast corner of the 1938 addition (with B at the upper right corner in the far ground). The addition wall is battered slightly to function as a retaining wall. It also was coated with a moisture barrier, but this is no longer effective. the 1½-inch gas line, visible in both test pits, comes from the main manifold on the west side of the market, up through the market attic and exits at this location where it goes to another building--it does not serve the market.

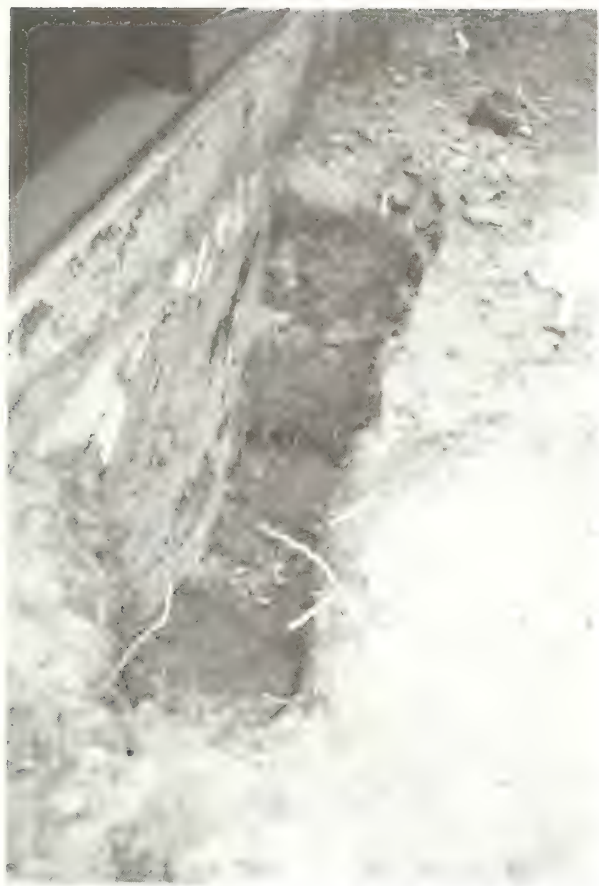
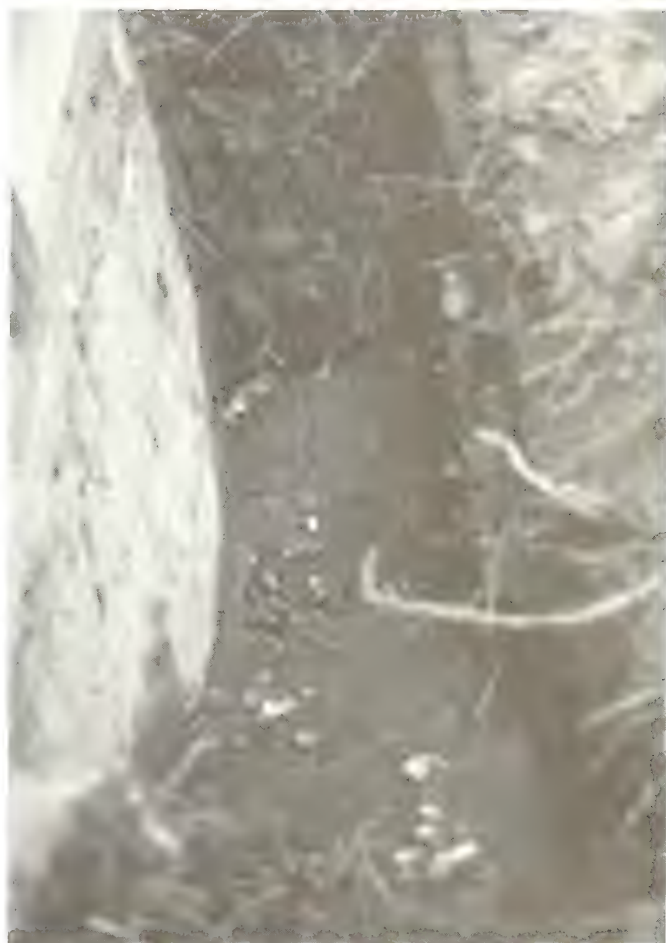
Figure A-11. Market, Test Pits D and E (10/86). These views show the extent of excavations along the east (rear) wall of the 1938 addition. Both of these holes are about 5-feet deep, both revealed the lip of the wall footing, confirmed the batter of the wall and its condition. The bitumin waterproof coating is consistently ineffective. Also, both pits included the 6-to-8-inch thick gravel drainage lense which helps establish the original grade and the depth of the proposed drainage excavation along the rear of the building.

functions as a retaining wall and is severely deteriorated. The wall is slightly battered and there is a minimal footing at the bottom of the wall (see figures Appendix A). Removing earth behind the wall or sloping the grade away from the wall and installing a perimeter drain is recommended. Removal of the lateral overburden on the foundation stem wall can be accomplished by adding a small retaining wall uphill from the building. The area between the building and the retaining wall would provide the required drainage around the building. The original concrete foundation wall was not adequately damp-proofed and along with the grade sloping toward the building has allowed water to penetrate the wall. The water in combination with numerous freeze-thaw cycles has resulted in exfoliation of concrete, efflorescence on the surface, and an array of small cracks (see figures 73 & 73). Much of the wall can be repaired by applying a mortar coating, while the small severely damaged area next to the loading dock may have to be replaced. The exterior of the concrete wall should also be damp-proofed.

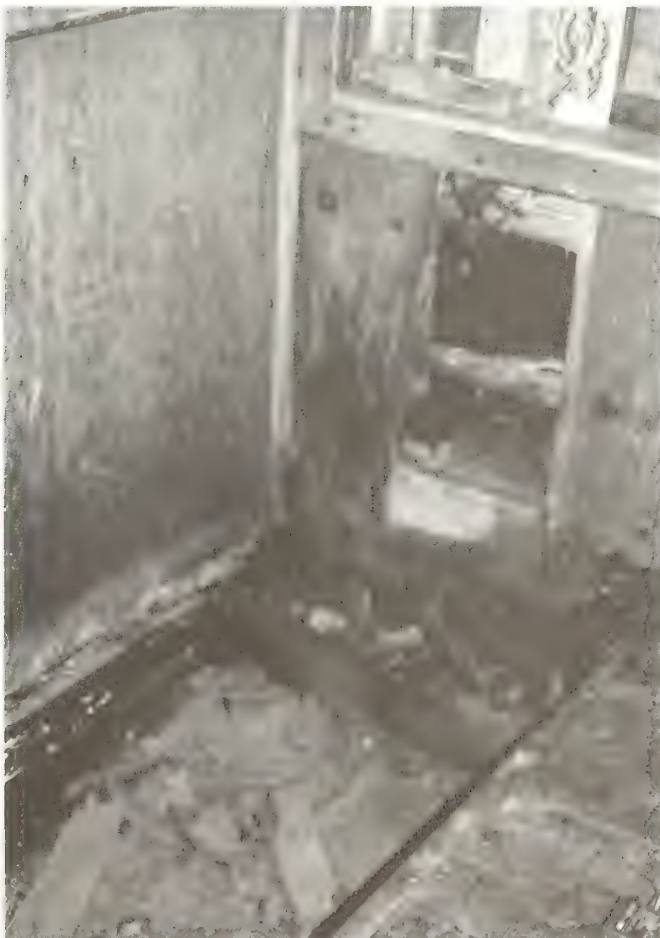
Figure A-12. Market Interior Fabric Investigation at Southeast, Room 100 (10/86). Plywood patches, part of a repair job of the 1970s or early 1980s, were removed from both floor and wall at this corner adjacent to the fireplace. The repair was done to replace rotted material, but did not address the cause of the rot--excessive moisture. Besides rotted joists, subfloor, beams and wall paneling, also revealed by this exploration was the shallowness of the crawl space and the fact that several crawl space ventilation windows are entirely blocked by exterior soil build-up.

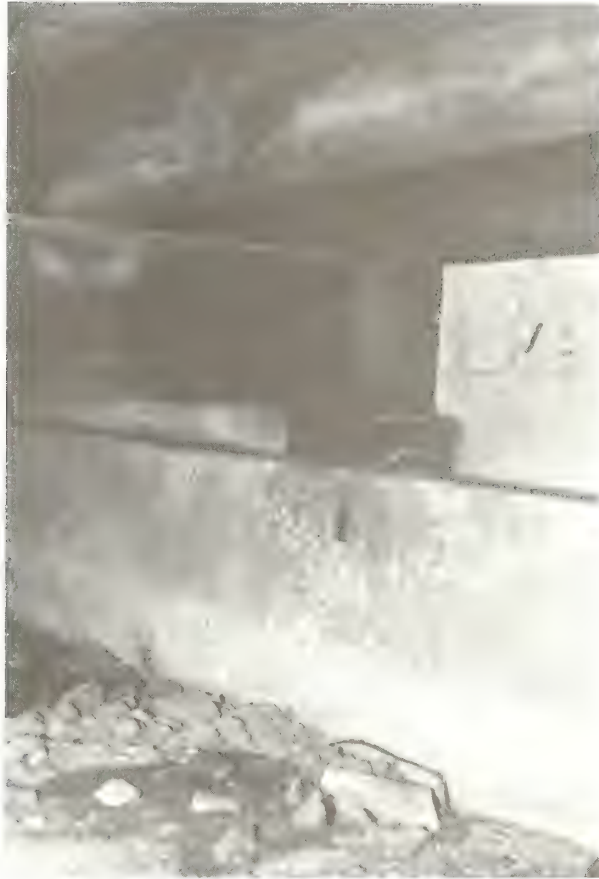
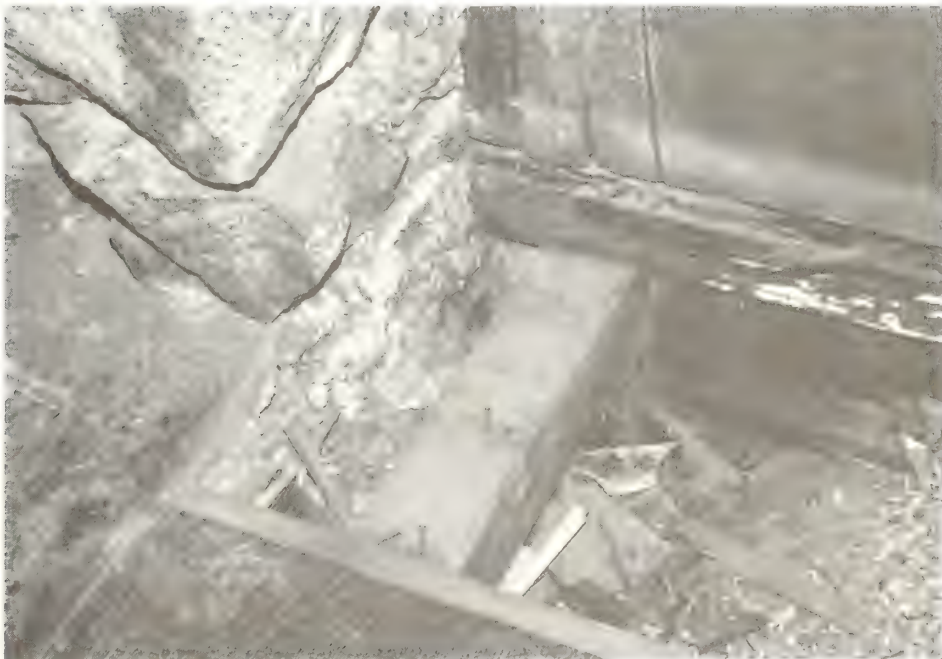
Figures A-13 and A-14. Market Crawl Space (5/86 and 10/86). The upper view shows the crawlspace as seen below the north end of the market where there is about 30 inches between the earth floor and the wooden subflooring. The lower view shows one of the 5 x 7 (6½" x 4-3/4" typically) floor beams vertically in contact with the earth. The end joist in the lower view is severely rotted and instrument readings indicated nearly 30% moisture content. Some of the crawl space earth should be excavated at the south end, several structural members must be replaced and the crawl space ventilation system needs to be improved.

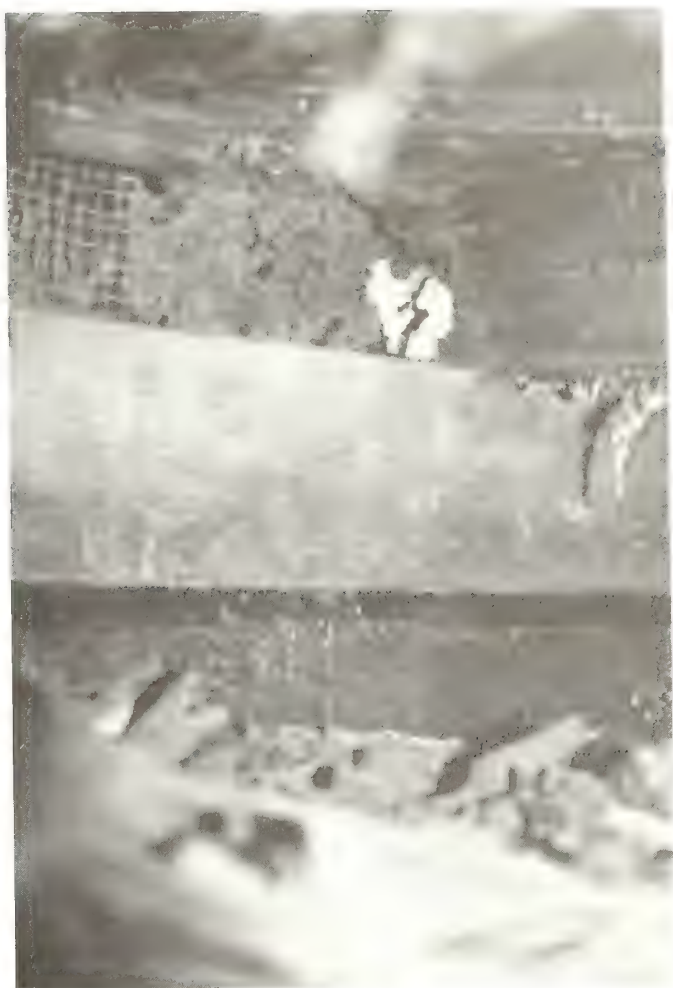
Figures A-15 and A-16. Market Crawl Space Vents (10/86). The above view is from inside the crawl space at the south end of the market (below room 100). This vent window is entirely blocked by earth on the exterior and partially obscured by debris and floor joist on the interior. The lower view is from the exterior of a vent on the market west wall. Most vents are reduced in effective size by the floor structural system, so it is especially important to eliminate additional, avoidable blockages. Also of note in the upper photograph is the decayed and fractured joist and beam, the result of excessive moisture and lack of adequate ventilation.

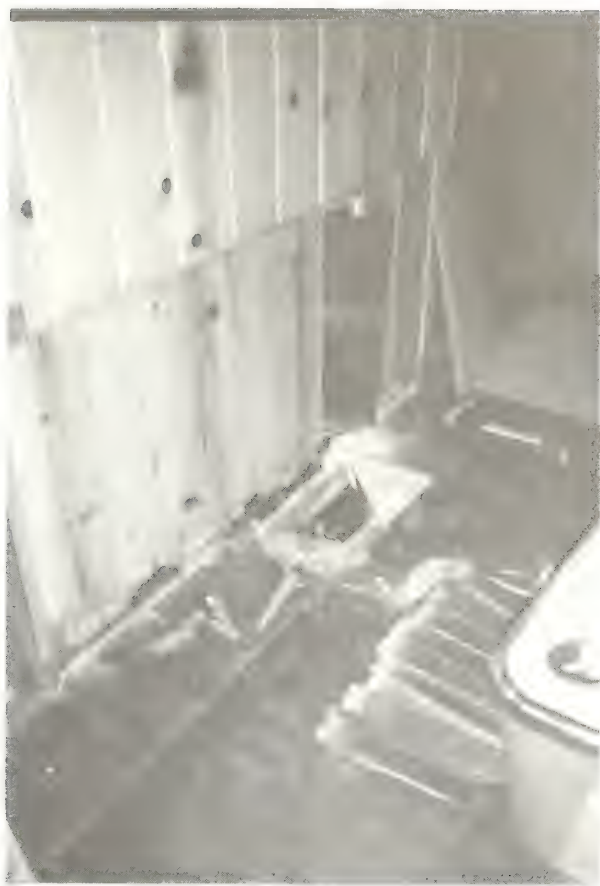
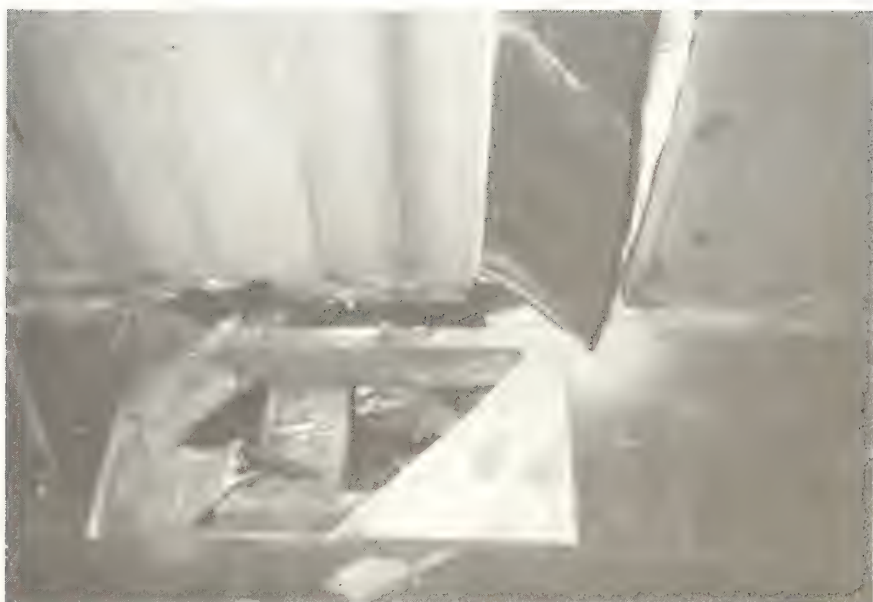
Figure A-17. Market Interior Fabric Investigation, West Side of Room 100 (10/86). A 27 x 19 inch section of flooring, which had been previously removed as part of a repair effort in the late 1970s or early 1980s, was taken up to reveal the nature of the "repair" and determine the extent of suspected deficiencies. Part of a joist and some subflooring had been replaced in the repair effort. Additional joists and subfloor are in need of similar treatment because of their advanced state of rot. The 1 x 4 base and a single wanescot panel were removed to reveal the cause of the deterioration. As in the investigation at the southeast corner, excessive moisture is the culprit--the crawl space is shallow, the vent window at this location is buried by the asphalt sidewalk outside, and the asphalt is used as a moisture barrier but traps moisture against the adjacent door threshold. See also next figure.

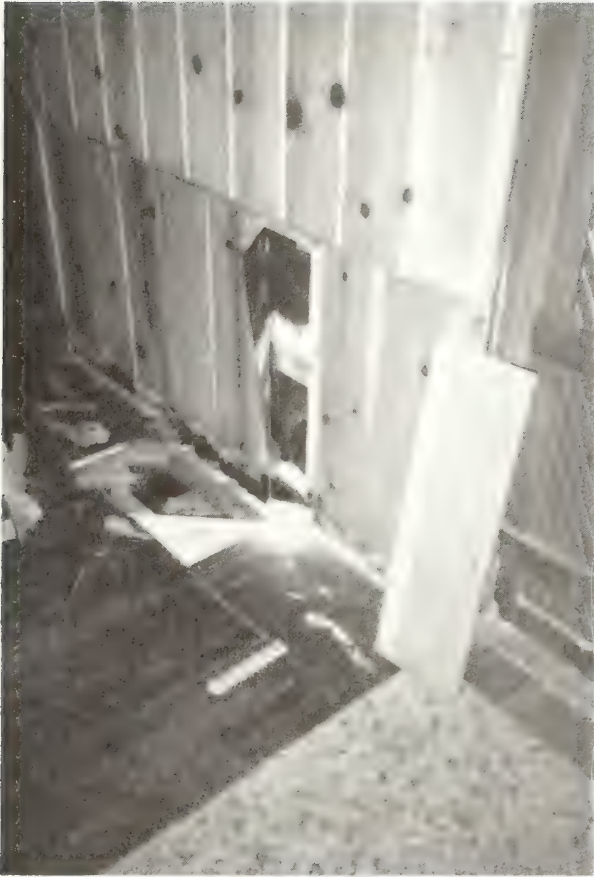
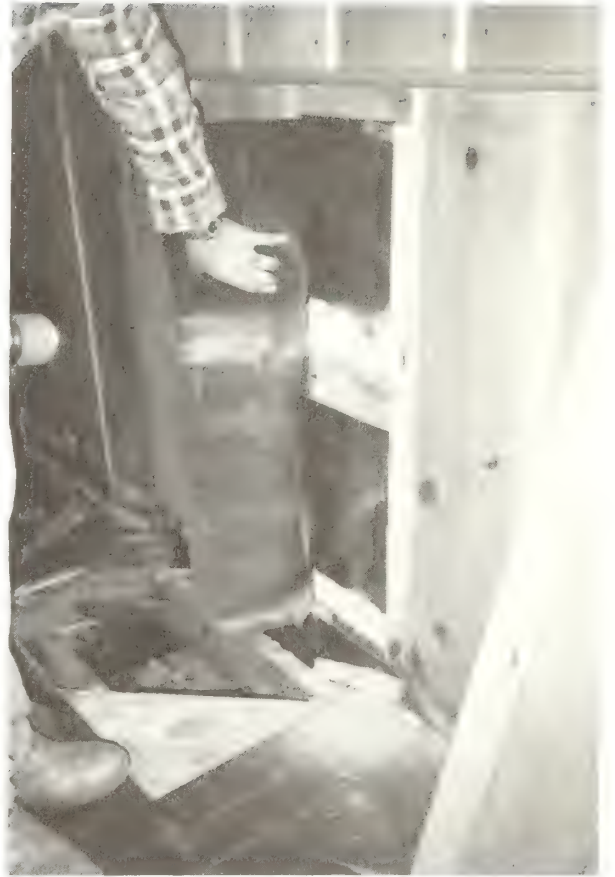
We suspect the insect infestation is that of the powder-post beetle (Trogoxylon parallelopipedum) which live beneath the surface of wooden members for months eating their way through the wood. As a rule, they do not enter painted wood. It is therefore essential to (a) apply paint thoroughly including the undersides of members and areas not easily painted and (b) to seal cracks and gaps in exterior wooden skin systems to prevent insects having access to interior, unpainted members.

Figure A-18. Market Interior Investigation at West Wall of Room 100 (10/86). These views show the wall cavity within the wainscot adjacent to the area of flooring taken up. Roofing felt was employed by the builders on the inside face of the exterior shiplap siding and on the interior side of the wall panel nailers. The cavity between was found to be full of frass from wood boring insects. An examination of the frass revealed living larval-stage insects, i.e., an active infestation is present. An examination of the exterior side of the wall revealed locations of beetle egress at the ineptly painted underside of horizontal puncheon members.

A treatment strategy should not only include replacement of rotten material and terminating the insect infestation, but should correct the physical deficiencies which encourage these agents of destruction.

Finally, moisture barriers are recommended for both the floor of the crawl space and wall systems. The roofing felt system in the market walls is not entirely effective--it needs to be replaced.

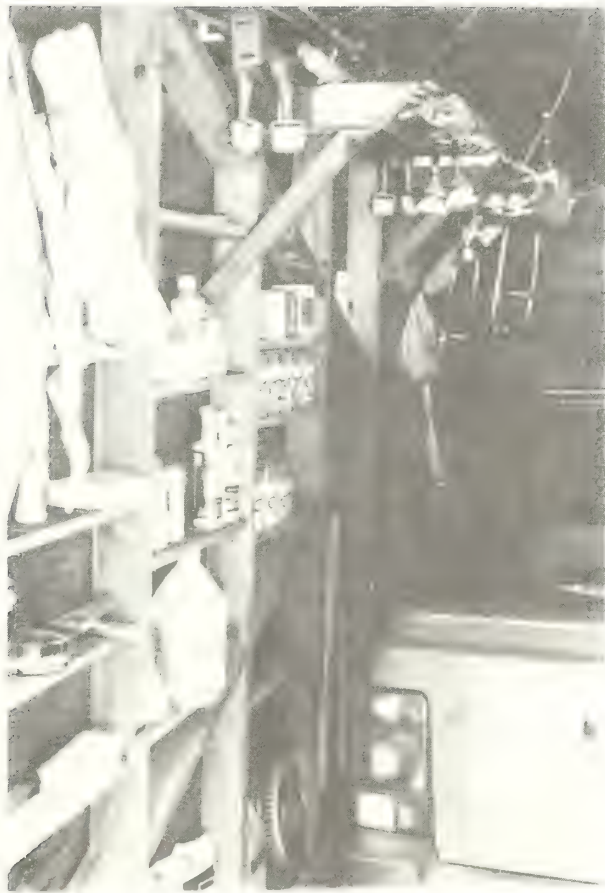
Figure B-1. Ranger Residence Garage Wall Framing and Diagonal Bracing

The ranger residence and garage foundation, floor system, walls and roof structure were all found to be in good condition (see figures B-1 & B-2). There was no evidence of cracks, permanent deflections, joint failure or displacement, connection breakdown, etc. The structure and significant elements need no repair. Calculations indicate the trusses are capable of supporting a total load of 135 psf (see figure B-9, sheet 10.11). According to the park staff no snow load reduction, by shoveling or any other method, was performed at this building and the resulting total load capacity of 135 psf appears to be adequate.

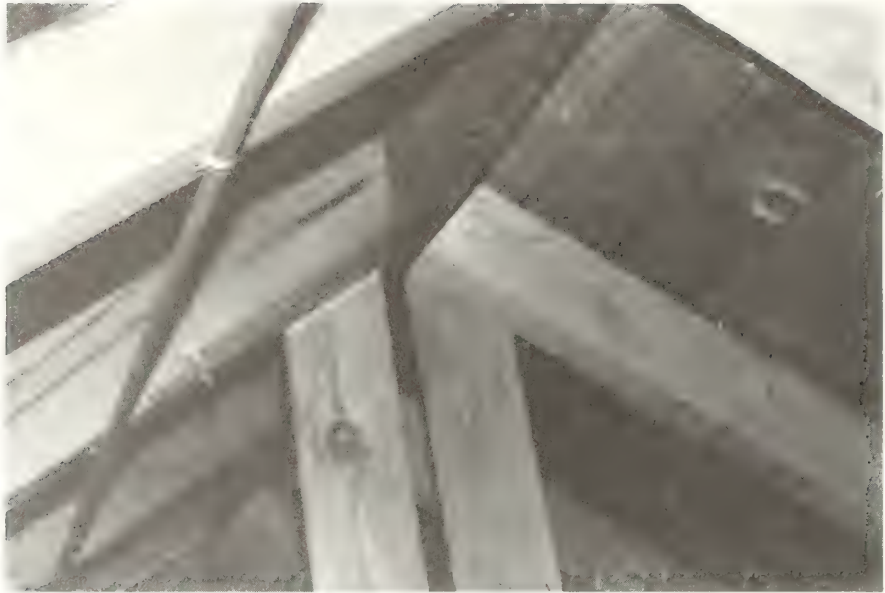
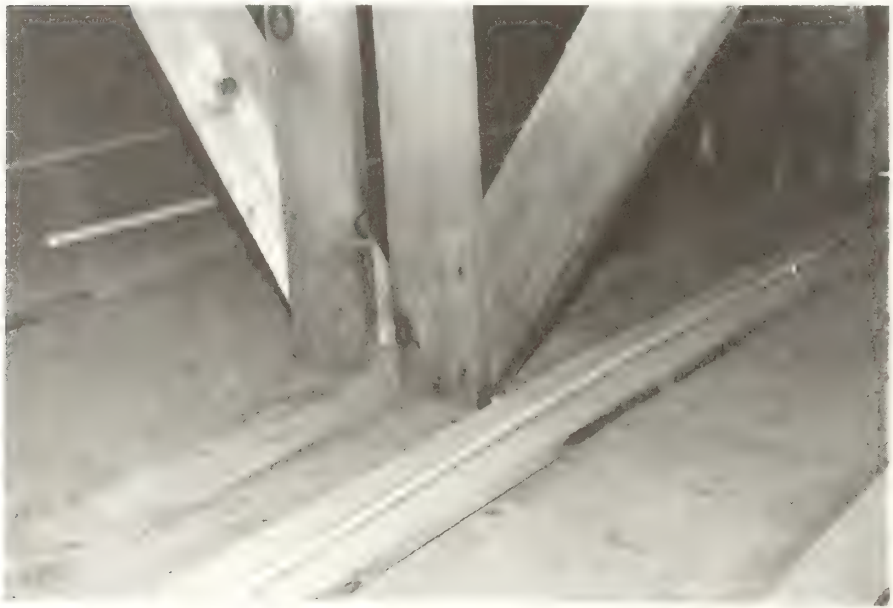
Figure B-4. Typical Market Building Roof Framing.

1. The roof system is under structured for a wood shake roofing system and would require snow shoveling unless it is reinforced.
2. When reroofing is undertaken, spot locations of water damaged rafters and sheathing should be replaced.

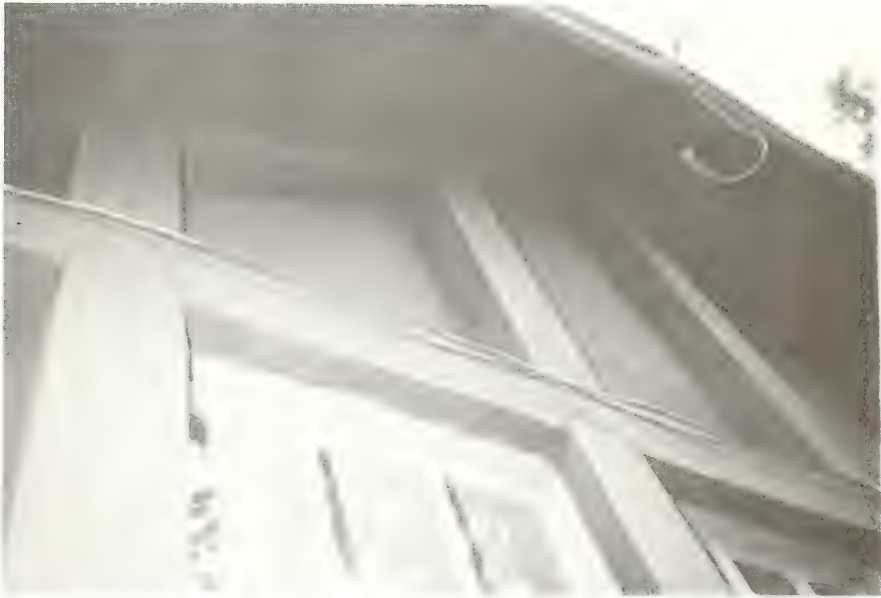
Figure C-3. Market Detail (10/86). The window fuse box is probably the original of 1938 electrification.

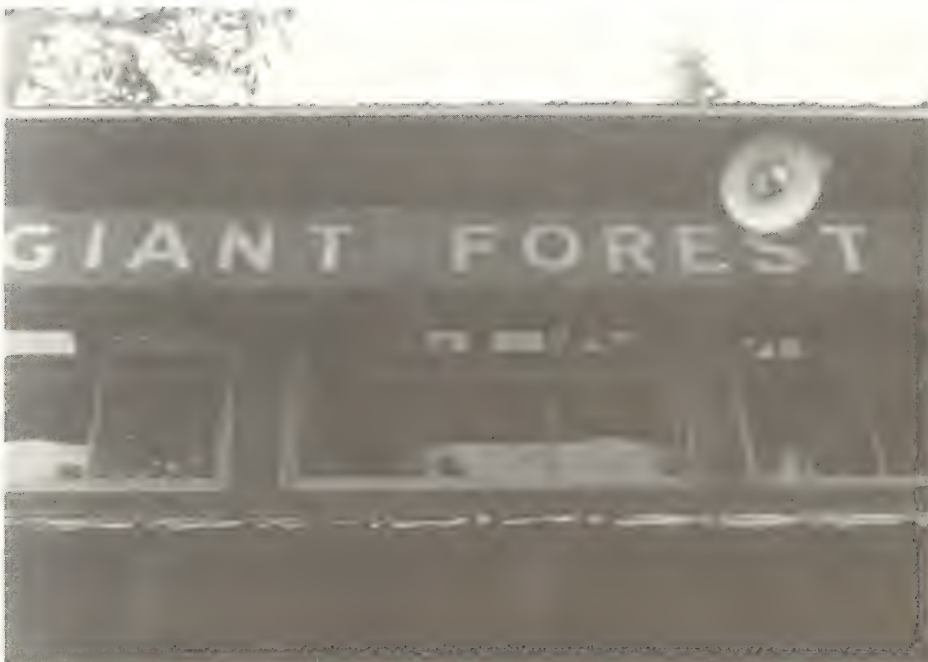
Figure C-4. Market Detail (10/86). Exterior mounted electrical conduit and A/C outlet on north facade.

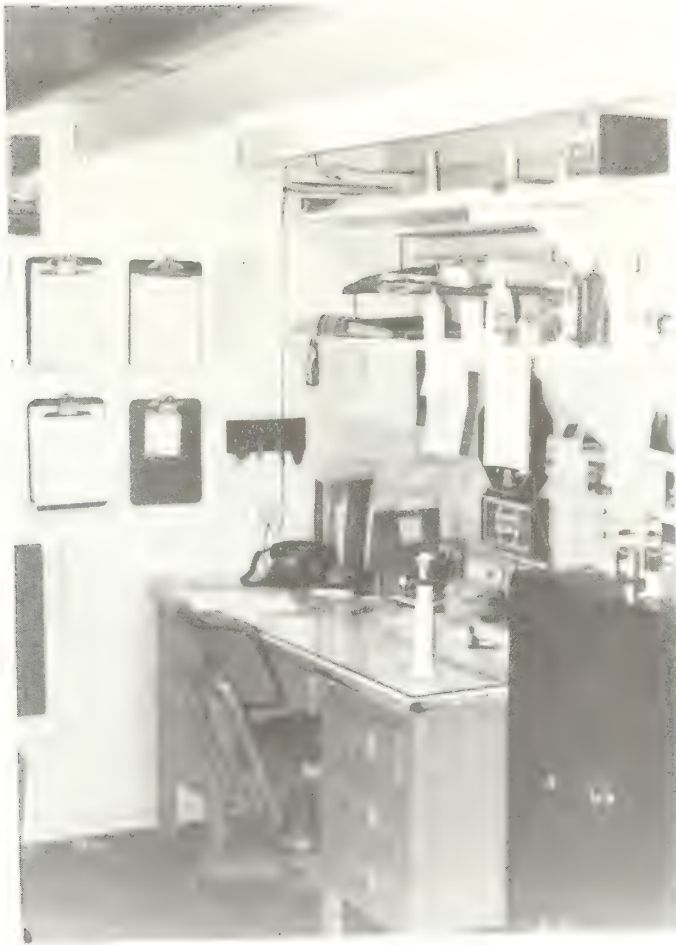
Figure C-5. Market, Manager's Office (5/86). The fluorescent fixture and surface mounted electrical conduit seen here were installed as part of the 1975 remodeling.

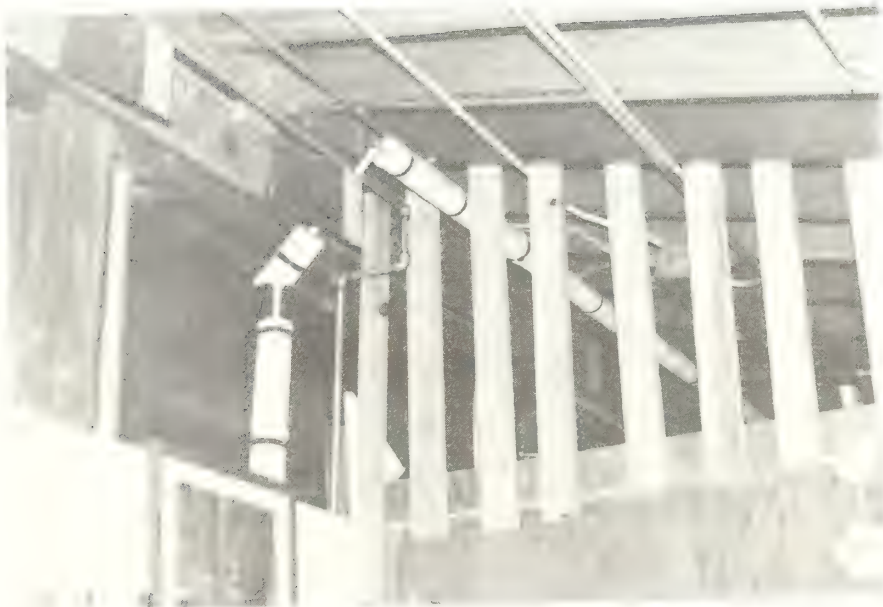
Figure C-6. Market Interior Detail (5/86). Joist mounted electrical conduit was installed in 1975. Note, insulation from waterline was tested for asbestos, see Appendix F.

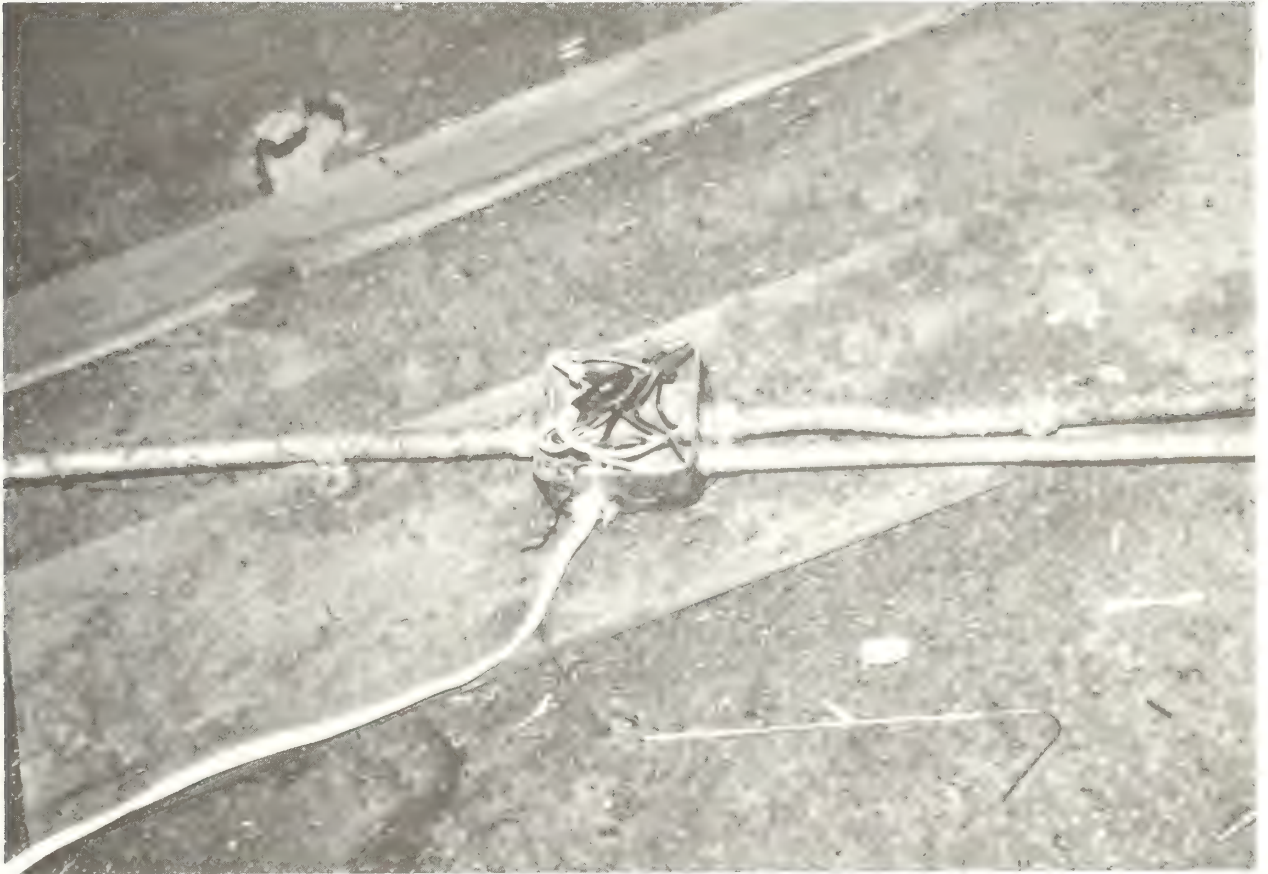
Figure C-7. Market Attic Detail (5/86). Close-up view of junction box and wiring, both in and out of conduit, as installed in the attic in 1975.

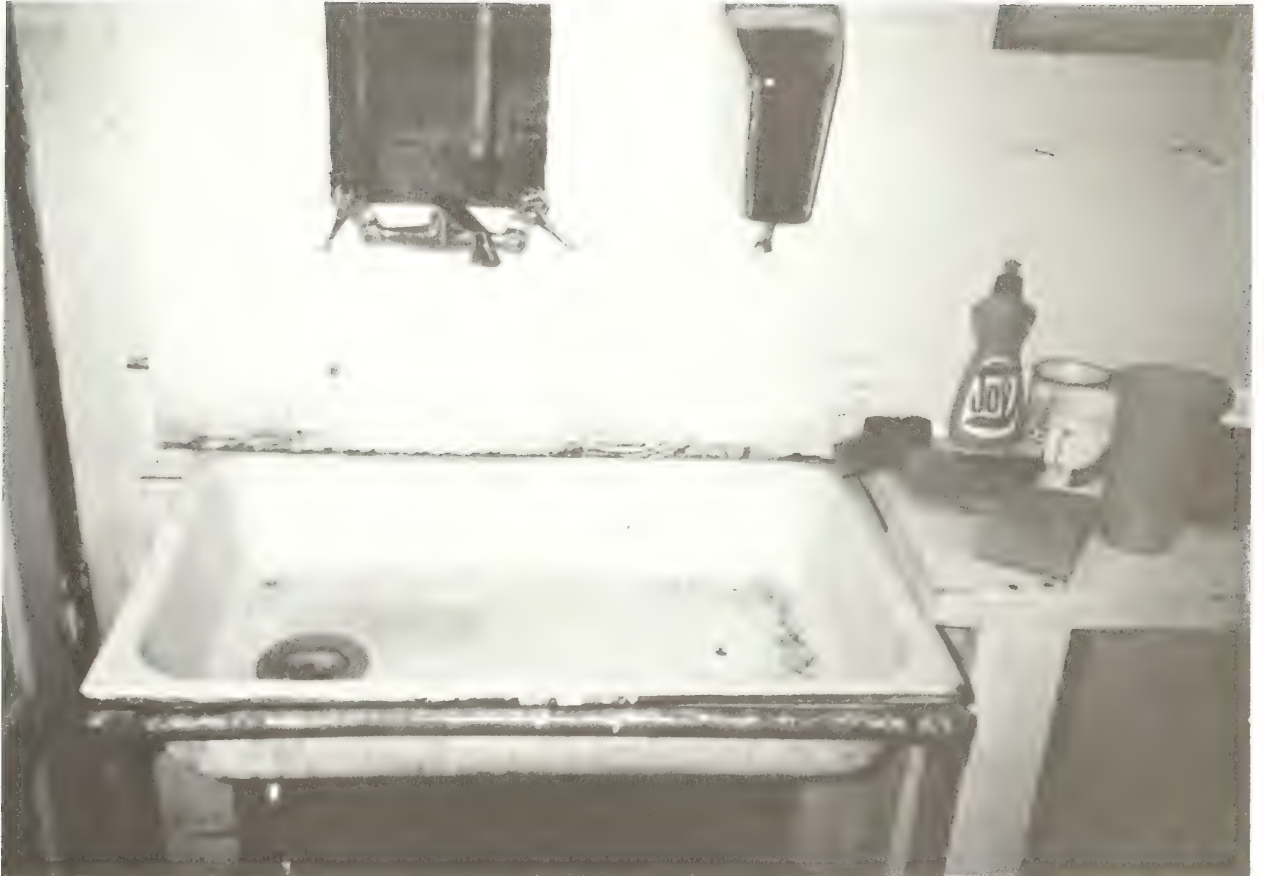
Figure D-1. Market--employee wash sink (5/86).

The market building is heated by three ceiling mounted propane-fired unit heaters. The plumbing system consists of three sinks and condensate waste from various coolers. The systems are adequate for current use, but should be replaced when the buildings undergo the rehabilitation planned.

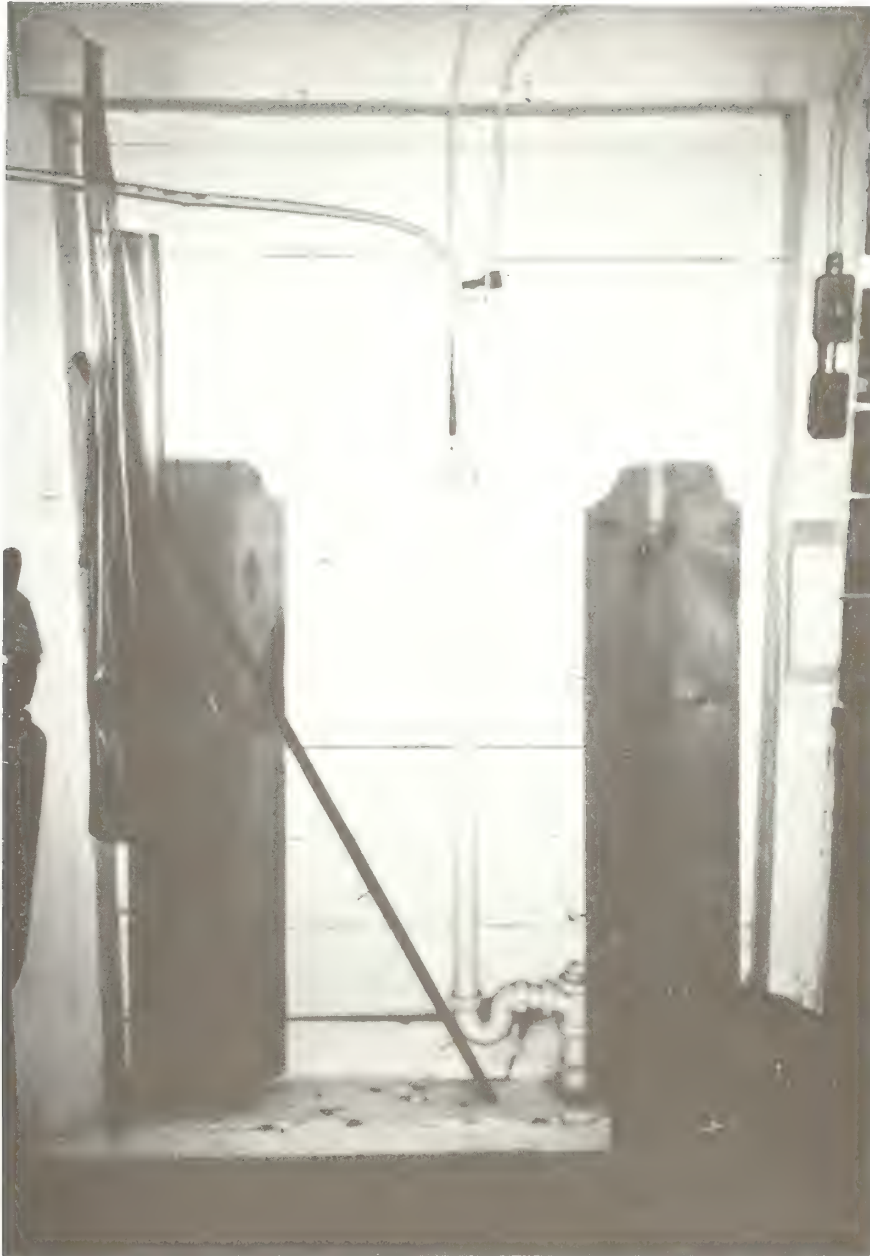
Figure D-2. Market--Condensation Drains from Walk-in Cooler (5/86).

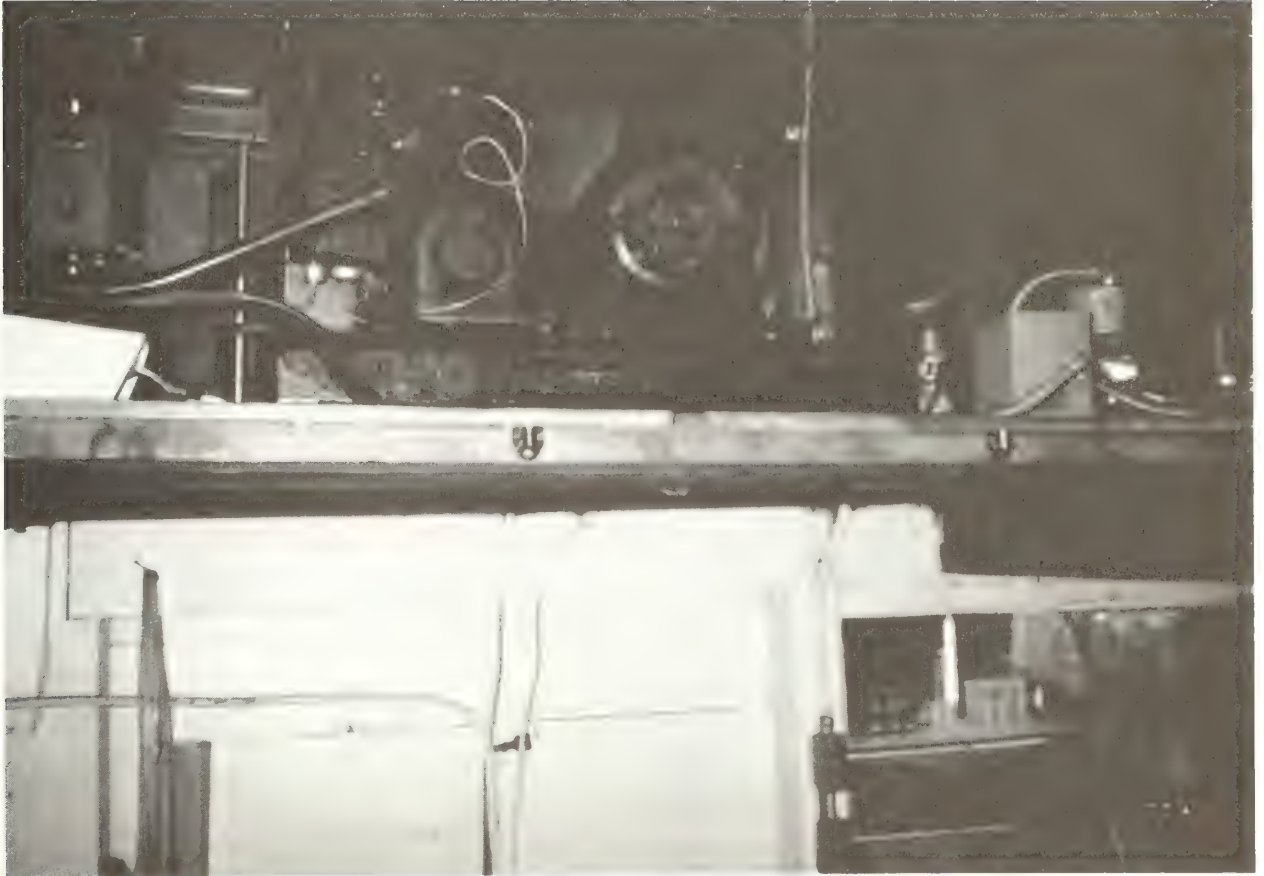
Figure D-3. Market--Walk-in Cooler Compressors (5/86).
